**MERRIMACK RIVER BASIN  
WILTON, NEW HAMPSHIRE**

**SOUHEGAN RIVER WATERSHED  
DAM NO. 33  
NH 00265  
NHWRB 254.34**

**PHASE I INSPECTION REPORT  
NATIONAL DAM INSPECTION PROGRAM**

**AUGUST 1979**

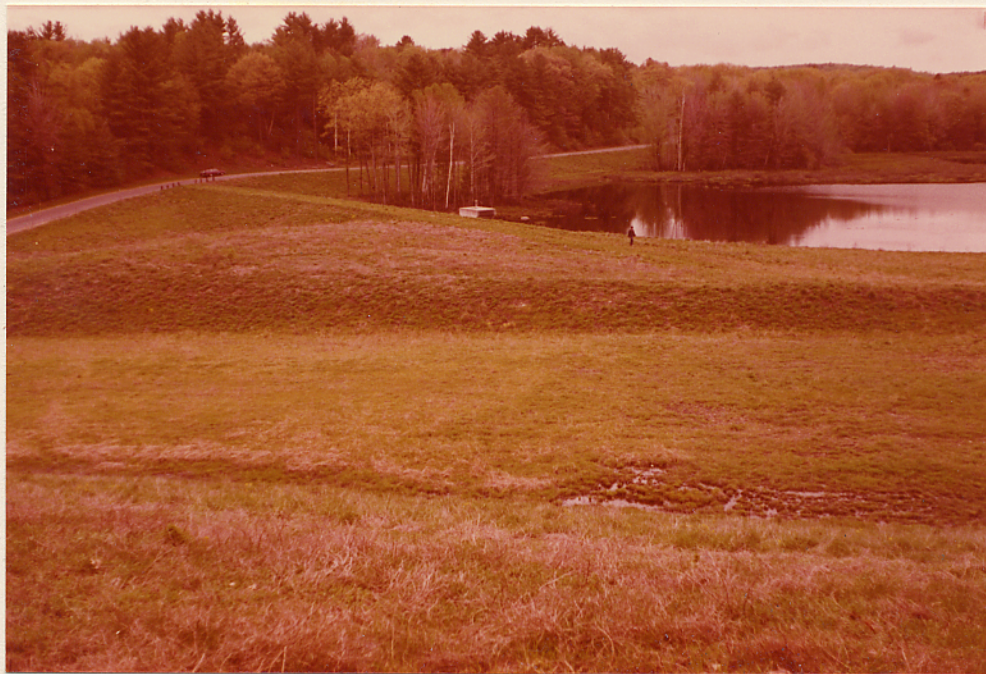
Overview photo from left side

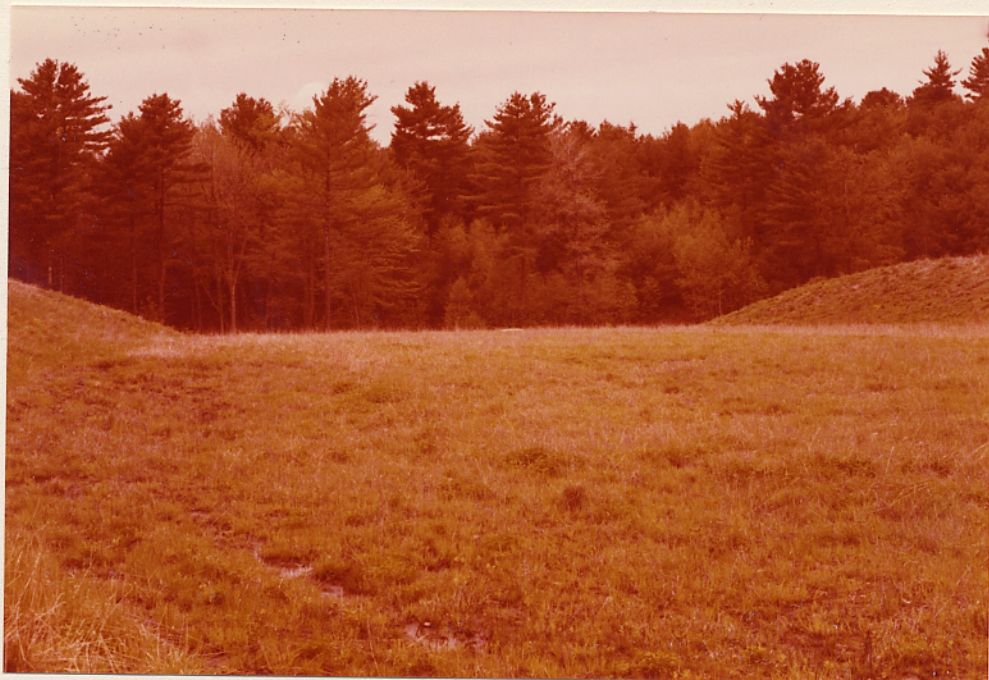
The emergency spillway is in good condition. There are wet spots in the channel but these are caused by natural groundwater or ponded runoff. There is a stone drain trench system in the downstream end of the emergency spillway. This system was added in 1977.

1. View of emergency spillway showing ponded water

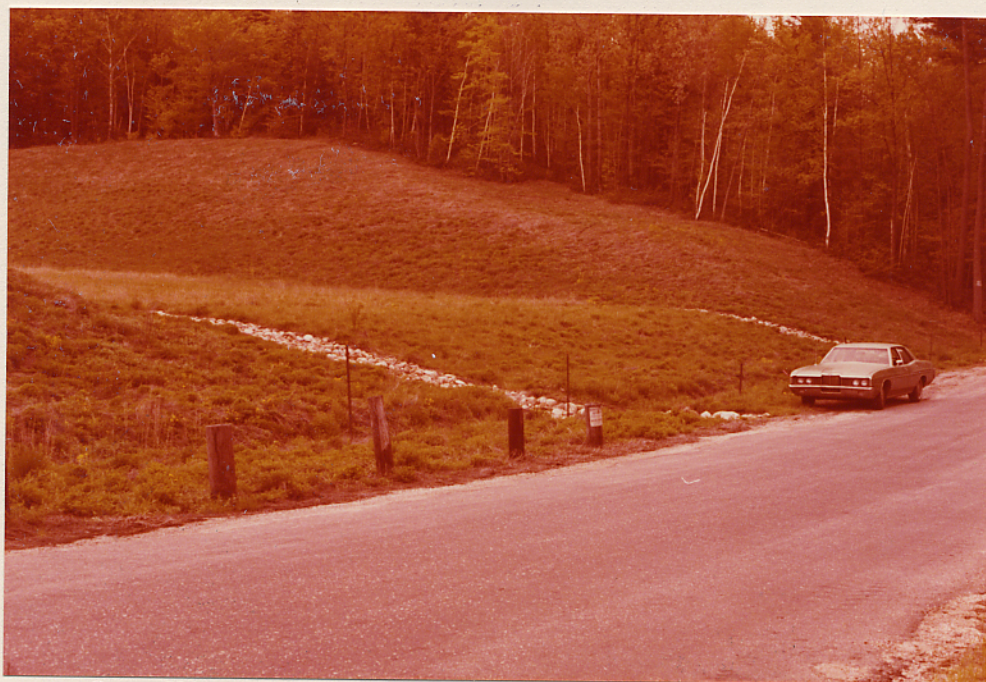
2. View of downstream end of emergency spillway showing drainage protection

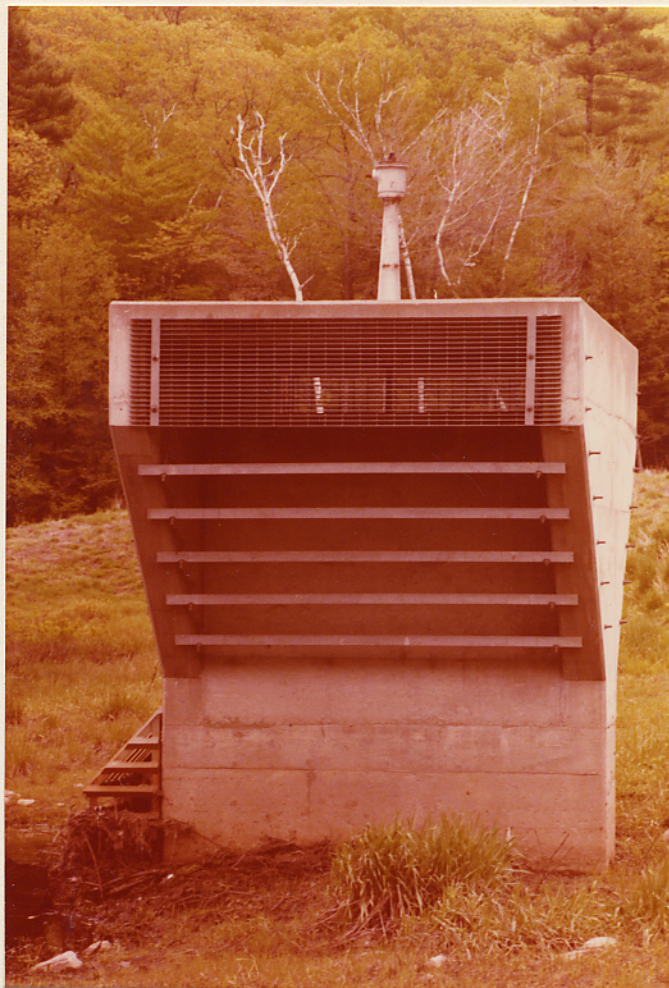
3. View of right side of drop inlet structure

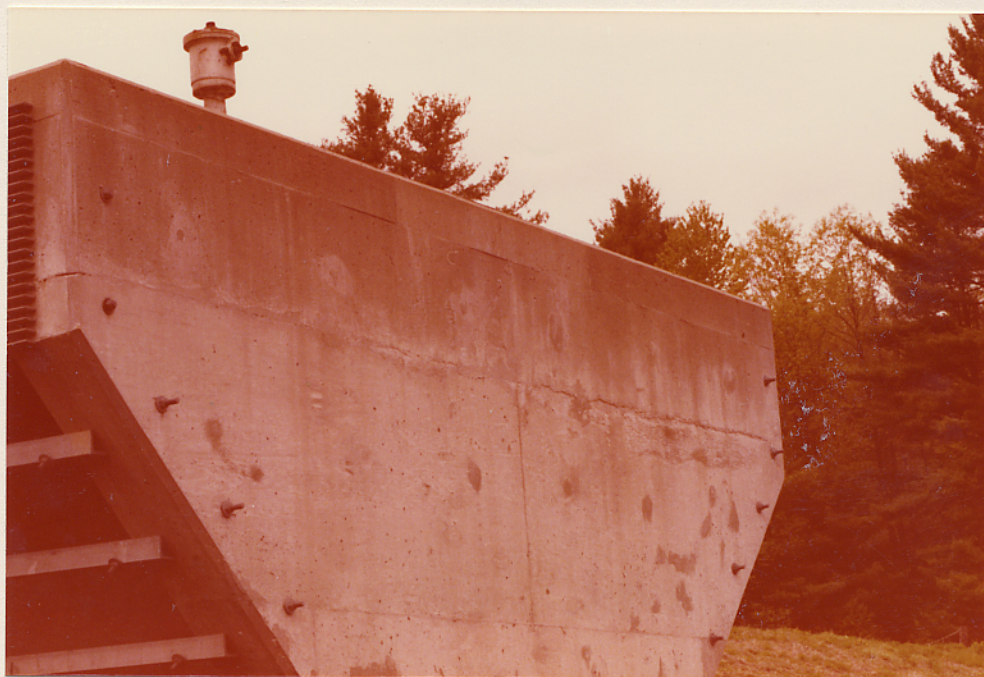
The structure is in good condition with some minor open horizontal construction joints and honeycombed concrete. The sluice gate bench stand is in good condition. The hand crank has been removed from the site to prevent unauthorized use. The trash racks are in good condition but are clogged with debris.

4. View showing joint erosion on drop inlet structure

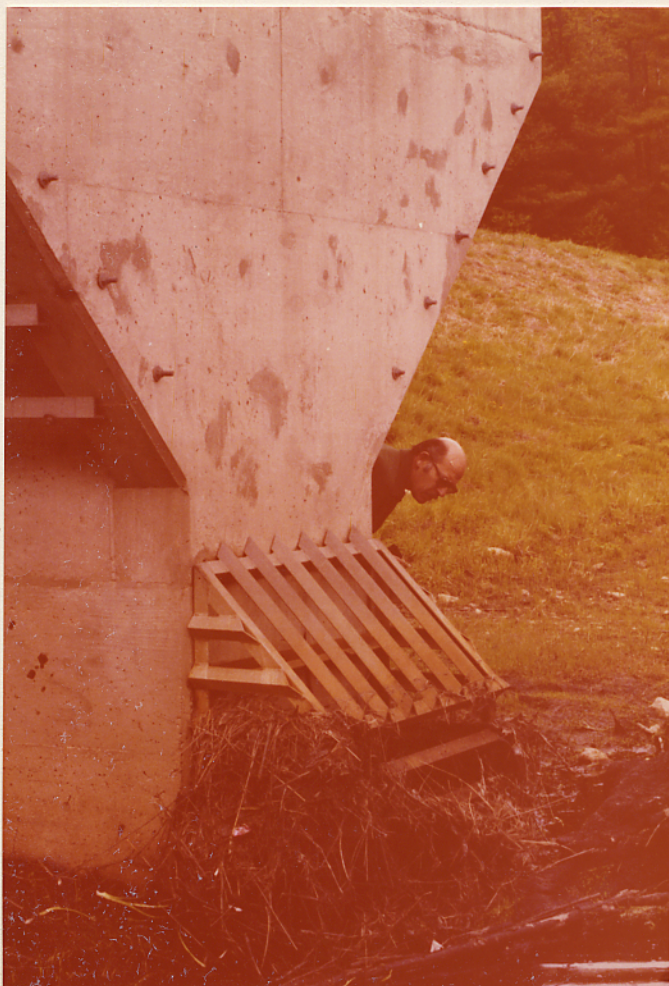
5. View of drop inlet structure showing debris in low stage trash rack

The dam is in GOOD condition at the present time. Remedial measures to be undertaken by the owner include: filling in animal burrows on slopes, mowing of slopes, removing debris from trash racks; including annual operation of drain gate in the inspection procedure; and developing a formal, written, emergency warning system for the dam. The program of annual technical inspections should be continued.

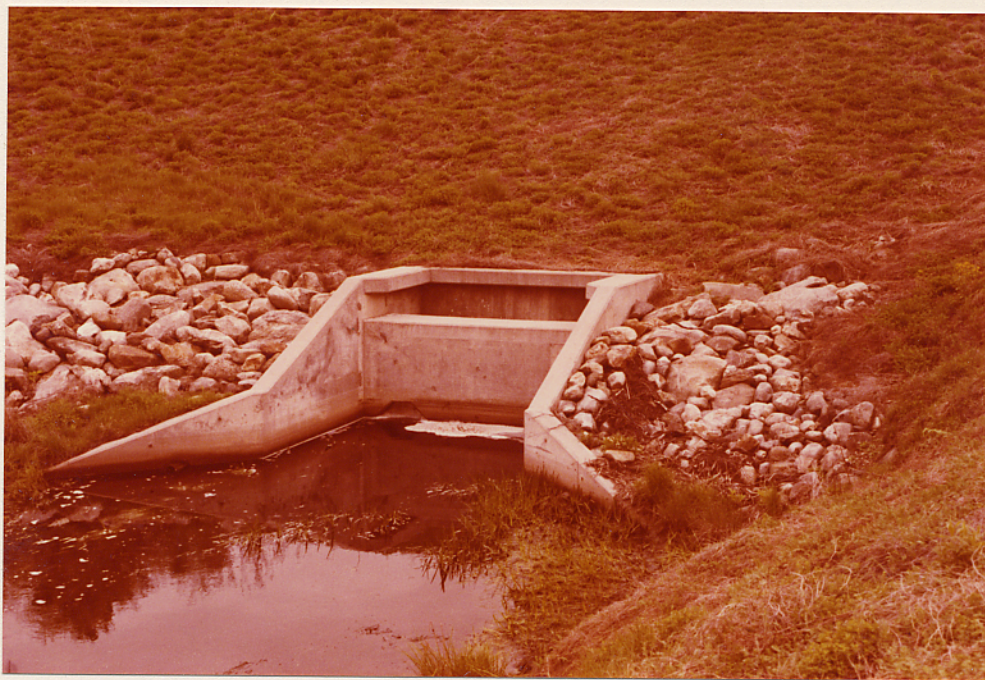
This structure is generally in good condition. There is some efflorescence on both ends of the top surface of the baffle wall and some minor erosion and staining of the headwall. There is no safety fence around this structure.

6. View of impact basin

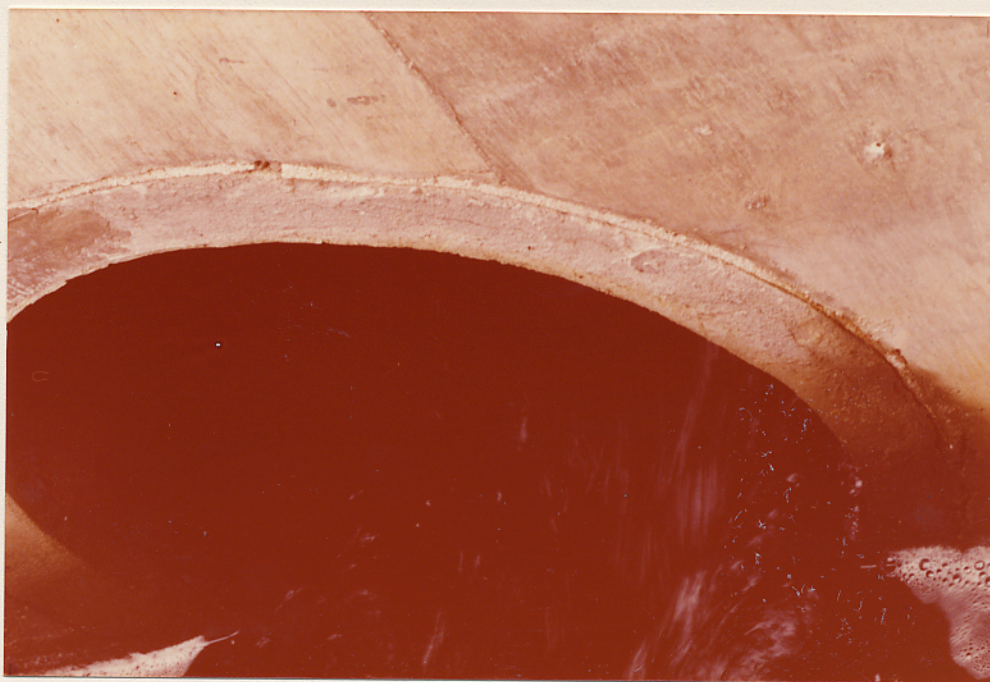
The downstream end of the outlet pipe is in good condition with no evidence of spalling, cracking, or efflorescence.

7. View of downstream end of outlet pipe showing deterioration from cavitation
